Focused Site Inspection Prioritization Report

General Hydraulics

USEPA ID No. ILD 984 767 806

August 31, 1995

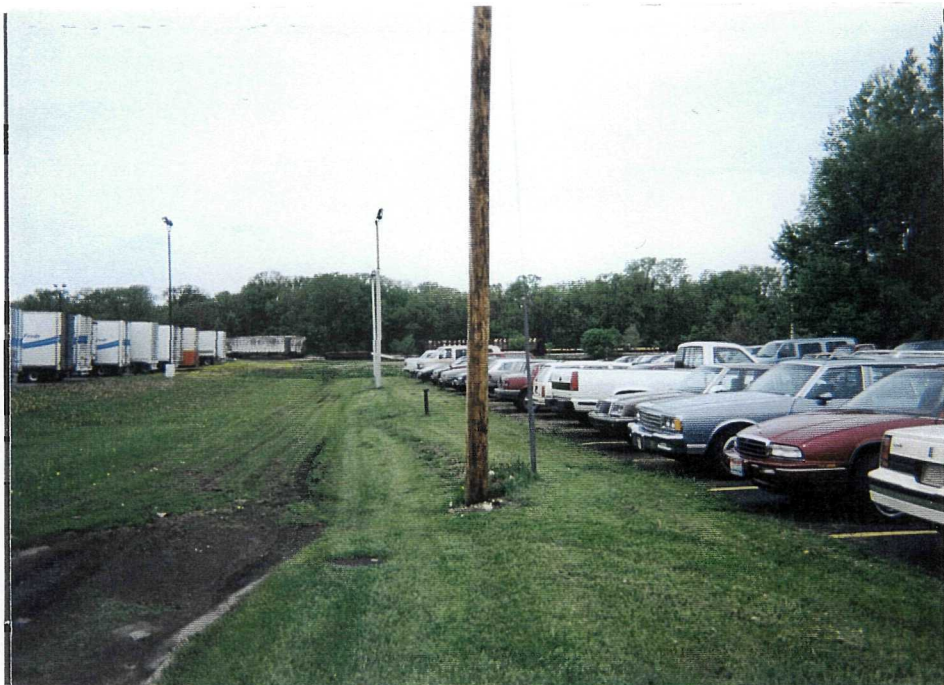
Date: May 17, 1995
Time: 1148
Photo Taken By: J. Noyes
Photo Number: 5
Site/ILD No.: General Hydraulics/ILD984767806
Direction of Photo: Facing West
Description: From entrance to site, center of Donner, Picture of south border including monitoring well.

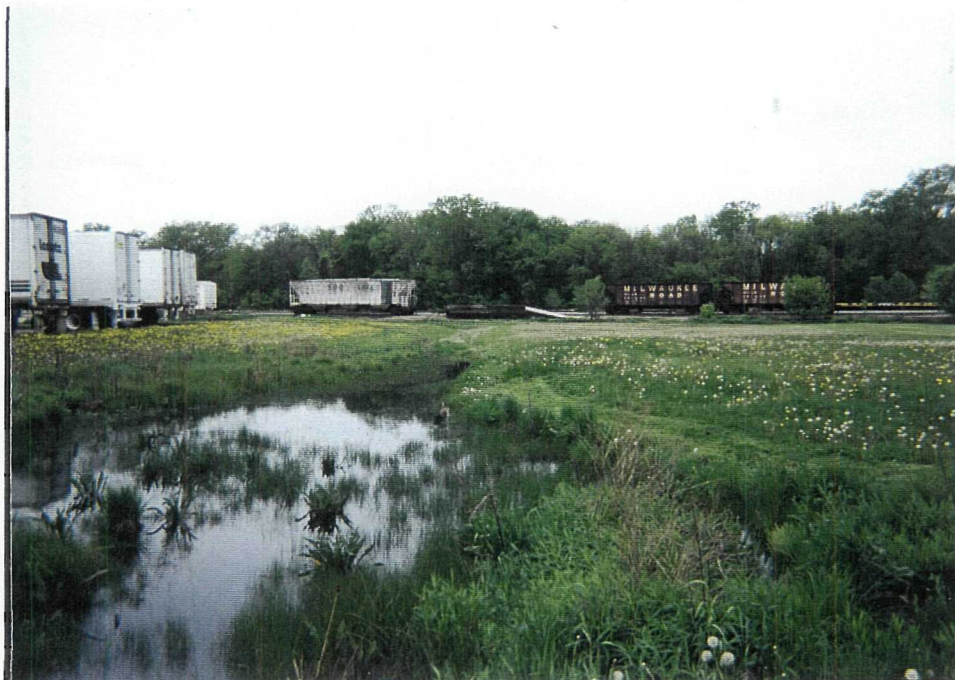
During the reconnaissance, surface drainage from the southern side of the employee parking lot appeared to flow west, where it ponded near the railroad tracks. Drainage from the border between NATCo and Trenwyth flows west, and ponds just west of Trenwyth's brick yard. Surface water ultimately flows into the Rock River. The stockpiled soil appears to be 15 to 20 feet wide, and 100 to 200 feet long. It is located along the railroad tracks near the western edge of the property.

Date: May 17, 1995
Time: 1154
Photo Taken By: J. Noyes
Photo Number: 7
Site/ILD No.: General Hydraulics/ILD 984767806
Direction of Photo: Facing West
Description: Ponding water, CP railroad in background.

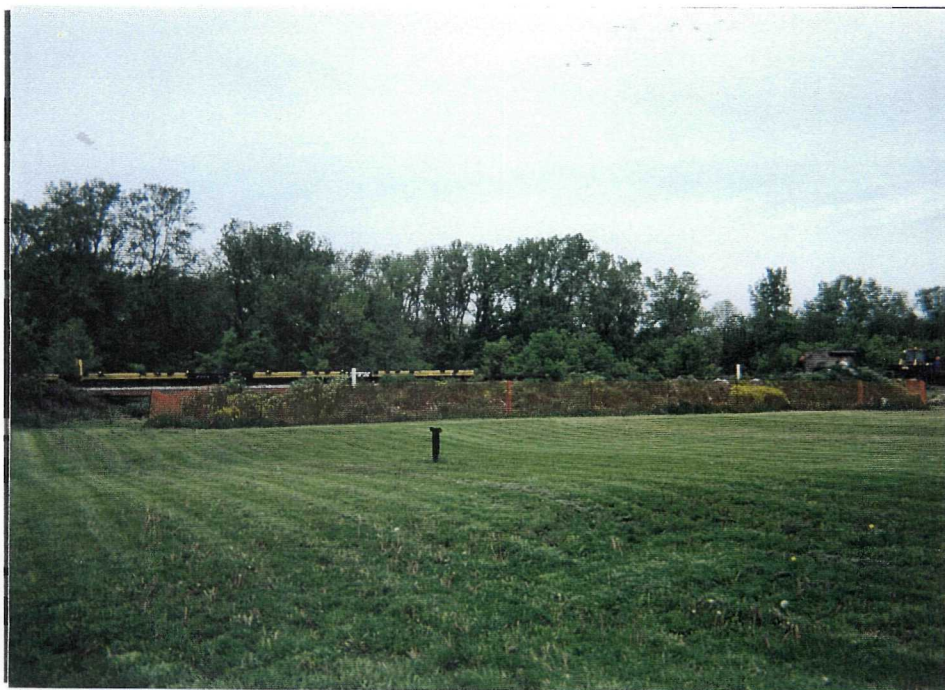
Date: May 17, 1995
Time: 1158
Photo Taken By: J. Noyes
Photo Number: 9
Site/ILD No.: General Hydraulics/ILD 984767806
Direction of Photo: Facing Northwest
Description: Photo of monitoring well in foreground and soil waste pile in background.

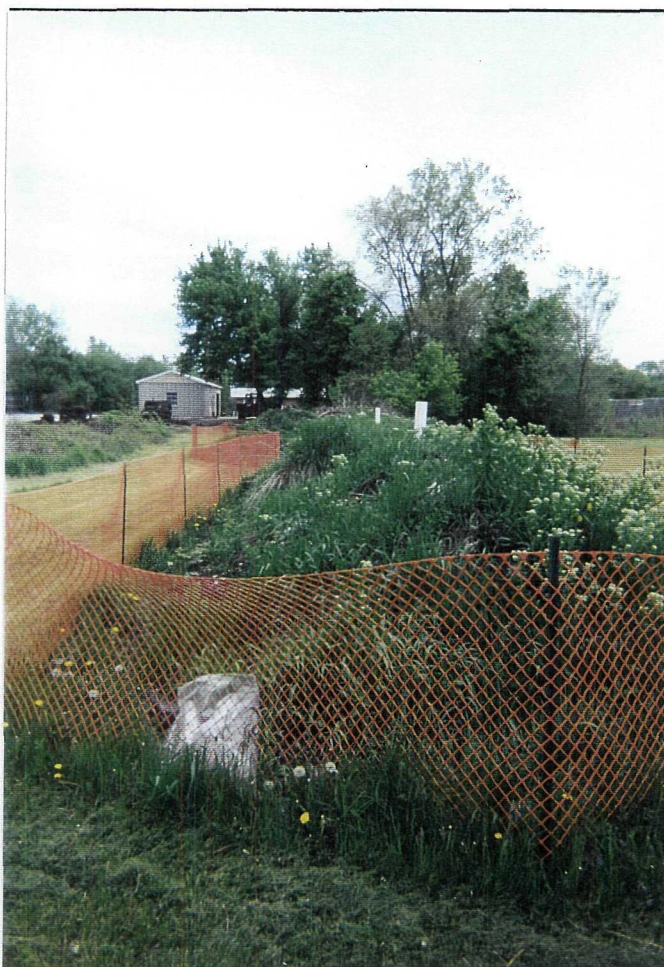
The three current property owners include NATCo, which occupies the southern half of the original property; Accra Plastics, which occupies the northeastern corner of the original property; and Trenwyth, which occupies the northwestern corner of the original site. In 1985, Henry Smith bought the property where Accra Plastics is now located; he sold the property to Accra in 1990. Allen and Rhoda Kingston bought the land where Trenwyth is located in April 1986; they lease the property to Trenwyth. NATCo bought its property in November 1986. Monitoring wells had been installed and drums had been removed from the property. In 1990, NATCo started excavation for a building addition. Potentially contaminated soils were encountered. NATCo hired Warzyn to conduct a soil gas survey, collect monitoring well samples, and remove and stockpile soils from the foundation excavations. IEPA sampled the onsite stockpiled soil in 1992. Currently, the soils are stockpiled on plastic, and surrounded by a plastic snow fence. Two plastic passive vents made of 4-inch diameter perforated PVC pipe are present.

Date: May 17, 1995
Time: 1200
Photo Taken By: J. Noyes
Photo Number: 10
Site/ILD No.: General Hydraulics/ILD 984767806
Direction of Photo: Facing North
Description: South end of stockpiled soil; note ventpipes, healthy vegetation growing, and plastic liner.

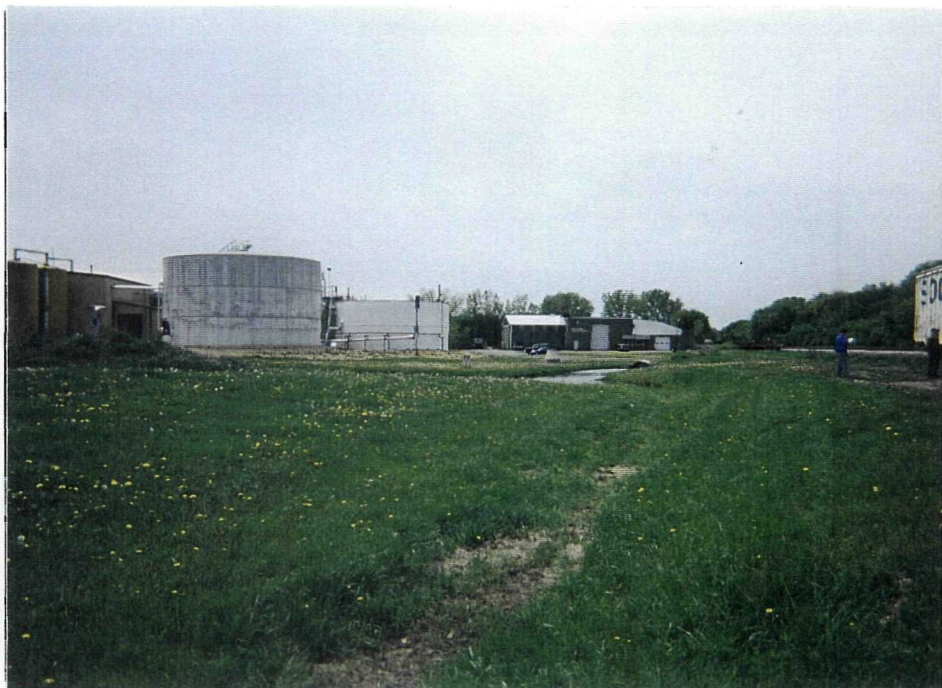
Date: May 17, 1995
Time: 1210
Photo Taken By: J. Noyes
Photo Number: 11
Site/ILD No.: General Hydraulics/ILD 984767806
Direction of Photo: Facing South
Description: From southwest corner of site.
Surface water appearing to drain south along tracks;
McLeary's Snack Foods w/Tanks and Precision
Fabricators in the Far South Background.

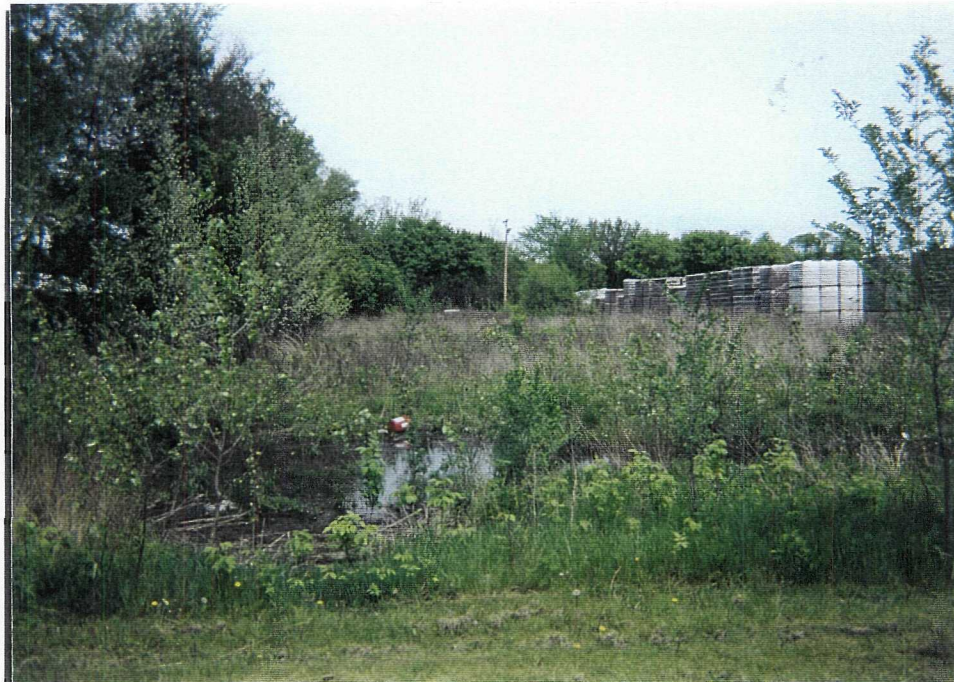
Date: May 17, 1995
Time: 1231
Photo Taken By: J. Noyes
Photo Number: 13
Site/ILD No.: General Hydraulics/ILD 984767806
Direction of Photo: Facing North
Description: From the same location as in Photo 12, ponded water west of Trenwyth Brickyard.

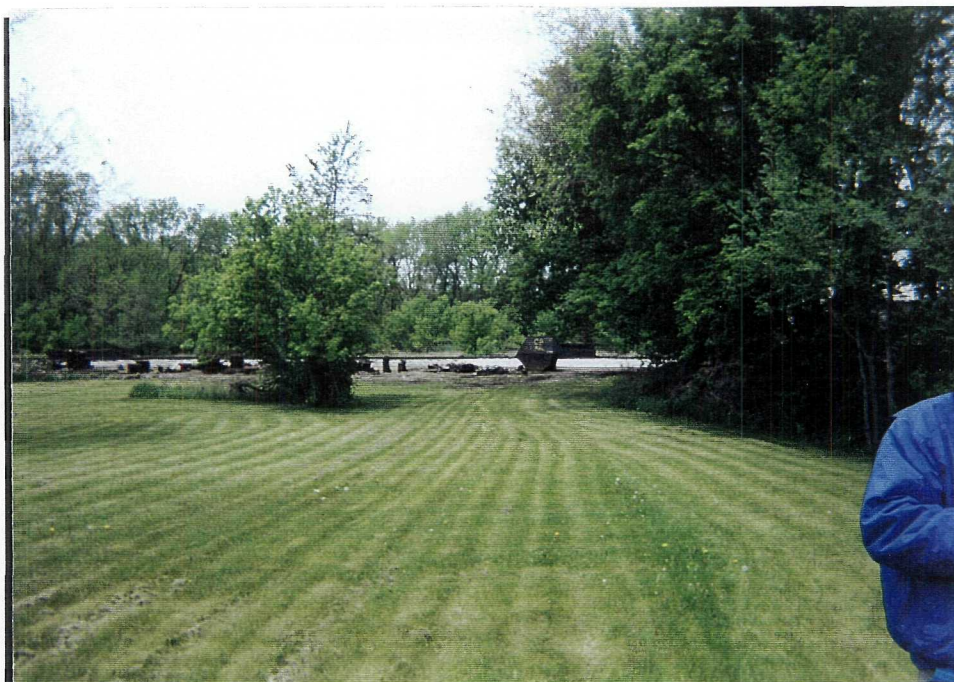
Date: May 17, 1995
Time: 1232
Photo Taken By: J. Noyes
Photo Number: 14
Site/ILD No.: General Hydraulics/ILD 984767806
Direction of Photo: West
Description: Taken from the same location as in Photo 12. CP railyard. Note: pails and metal plates.

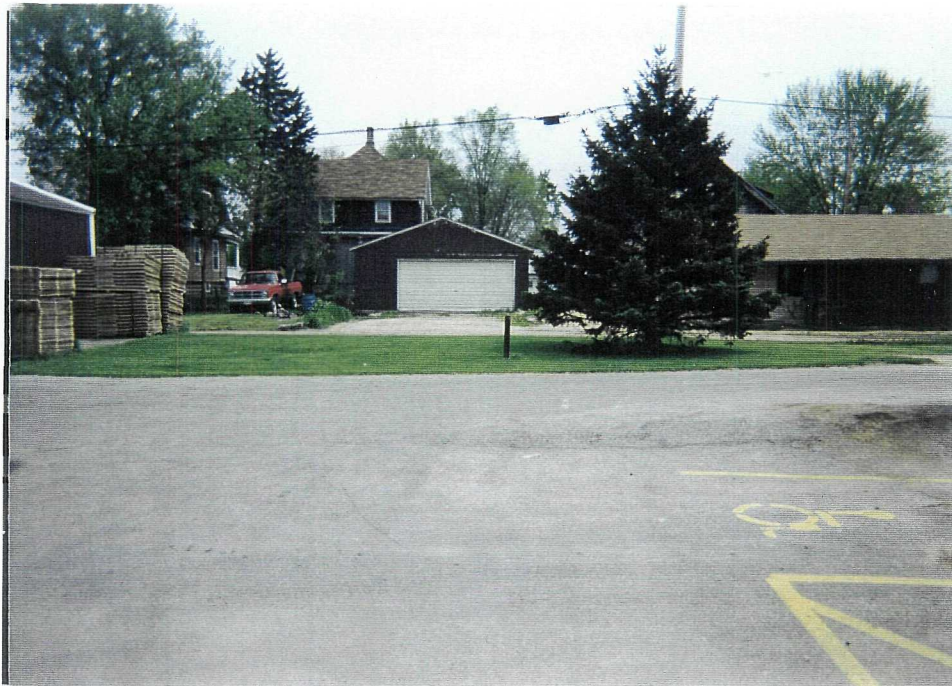
Date: May 17, 1995
Time: 1304
Photo Taken By: J. Noyes
Photo Number: 23
Site/ILD No.: General Hydraulics/ILD 984767806
Direction of Photo: East
Description: From center of east edge of site.
Monitoring well and residential homes.
